Technical Bulletin | TPPL Batteries: Identifying and Assessing Swelling

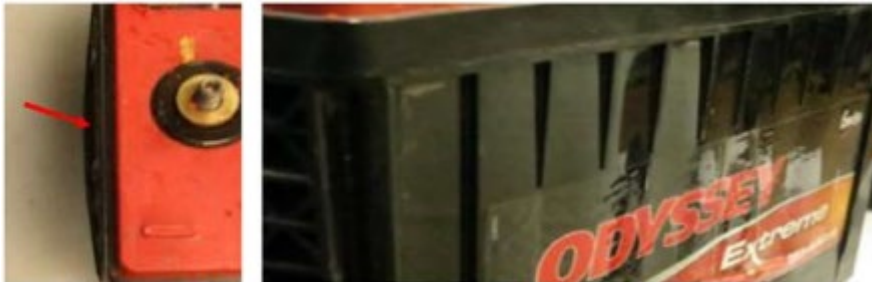
- Caution (Moderate): Visible deformation indicates potential issues, usually environmental or related to deep or over-discharge conditions. Allow hot batteries to cool. If swelling reduces after cooling,

recharge and test the battery. Typically, it is evident at the end wall.

- Moderate Swelling: Plan preventive maintenance or replacement based on test results.
- Severe Swelling: Immediately disconnect, isolate and replace.

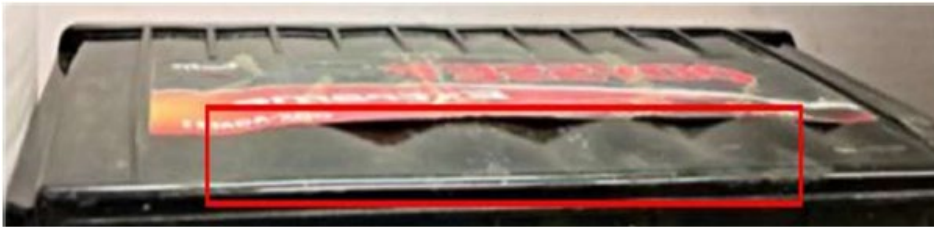
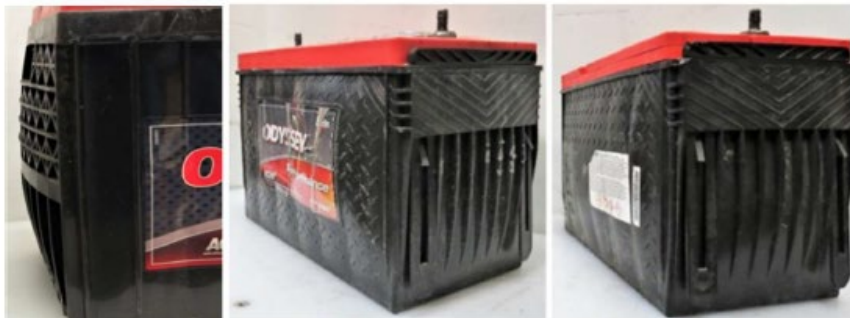
- Critical (Severe): Significant deformation requires immediate isolation and battery replacement. These batteries are too far gone to consider serviceable.
