## Installing an ODYSSEY PC925LMJ in 1997 to Current Year FL –FLH Harley Davidson

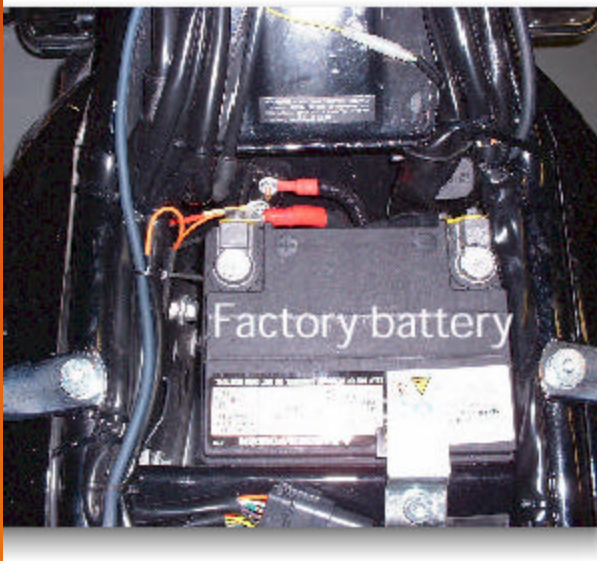
Photo #1 shows the factory battery installed.

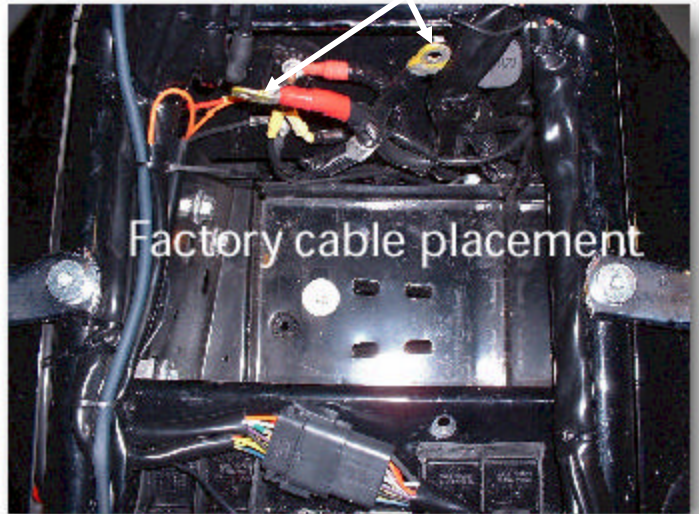
Photo #3 – shows the nut that you will need to loosen so the negative battery cable can be re-routed.

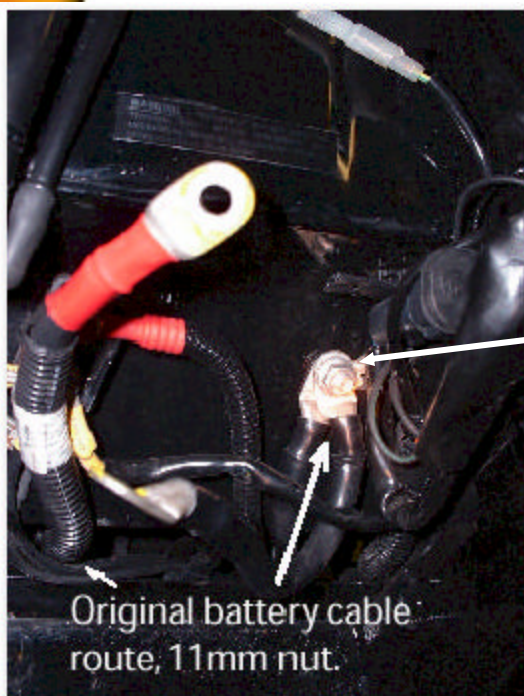
Original battery cable route, 11mm nut.

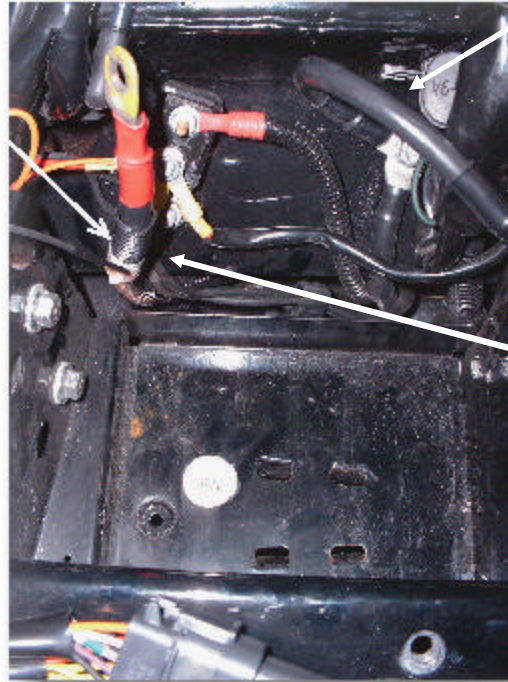
Photo #4 shows the negative cable in its new position. Rotate to the 10 o'clock position. Re-tighten the nut.

Re-route the positive cable from behind the circuit breaker wires to allow freedom of movement to the left side of the chassis.

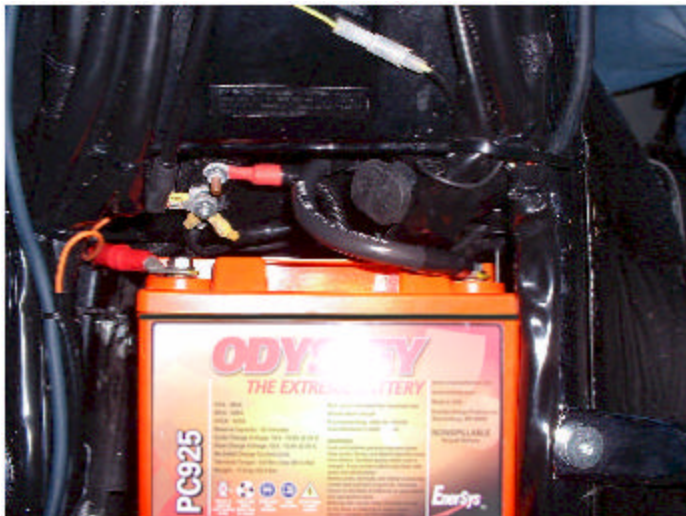
Photo #5 – Install your ODYSSEY battery and attach the cables as shown. The negative cable will clear the seat with room to spare.

Do not over tighten the battery connections. Torque the connections to a maximum of 60 in-lbs for a PC925LMJ. **Over tightening will damage your battery and void the warranty.**
